Debris/Ice/TPS Assessment and Integrated Photographic Analysis for Shuttle Mission STS-57

(NASA-TM-107562) DEBRIS/ICE/TPS
ASSESSMENT AND INTEGRATED
PHOTOGRAPHIC ANALYSIS FOR SHUTTLE
MISSION STS-57 Final Report, 18
Jun. - 2 Jul. 1993 (NASA) 131 p

DEBRIS/ICE/TPS ASSESSMENT
AND
PHOTOGRAPHIC ANALYSIS
OF
SHUTTLE MISSION STS-57

June 21, 1993

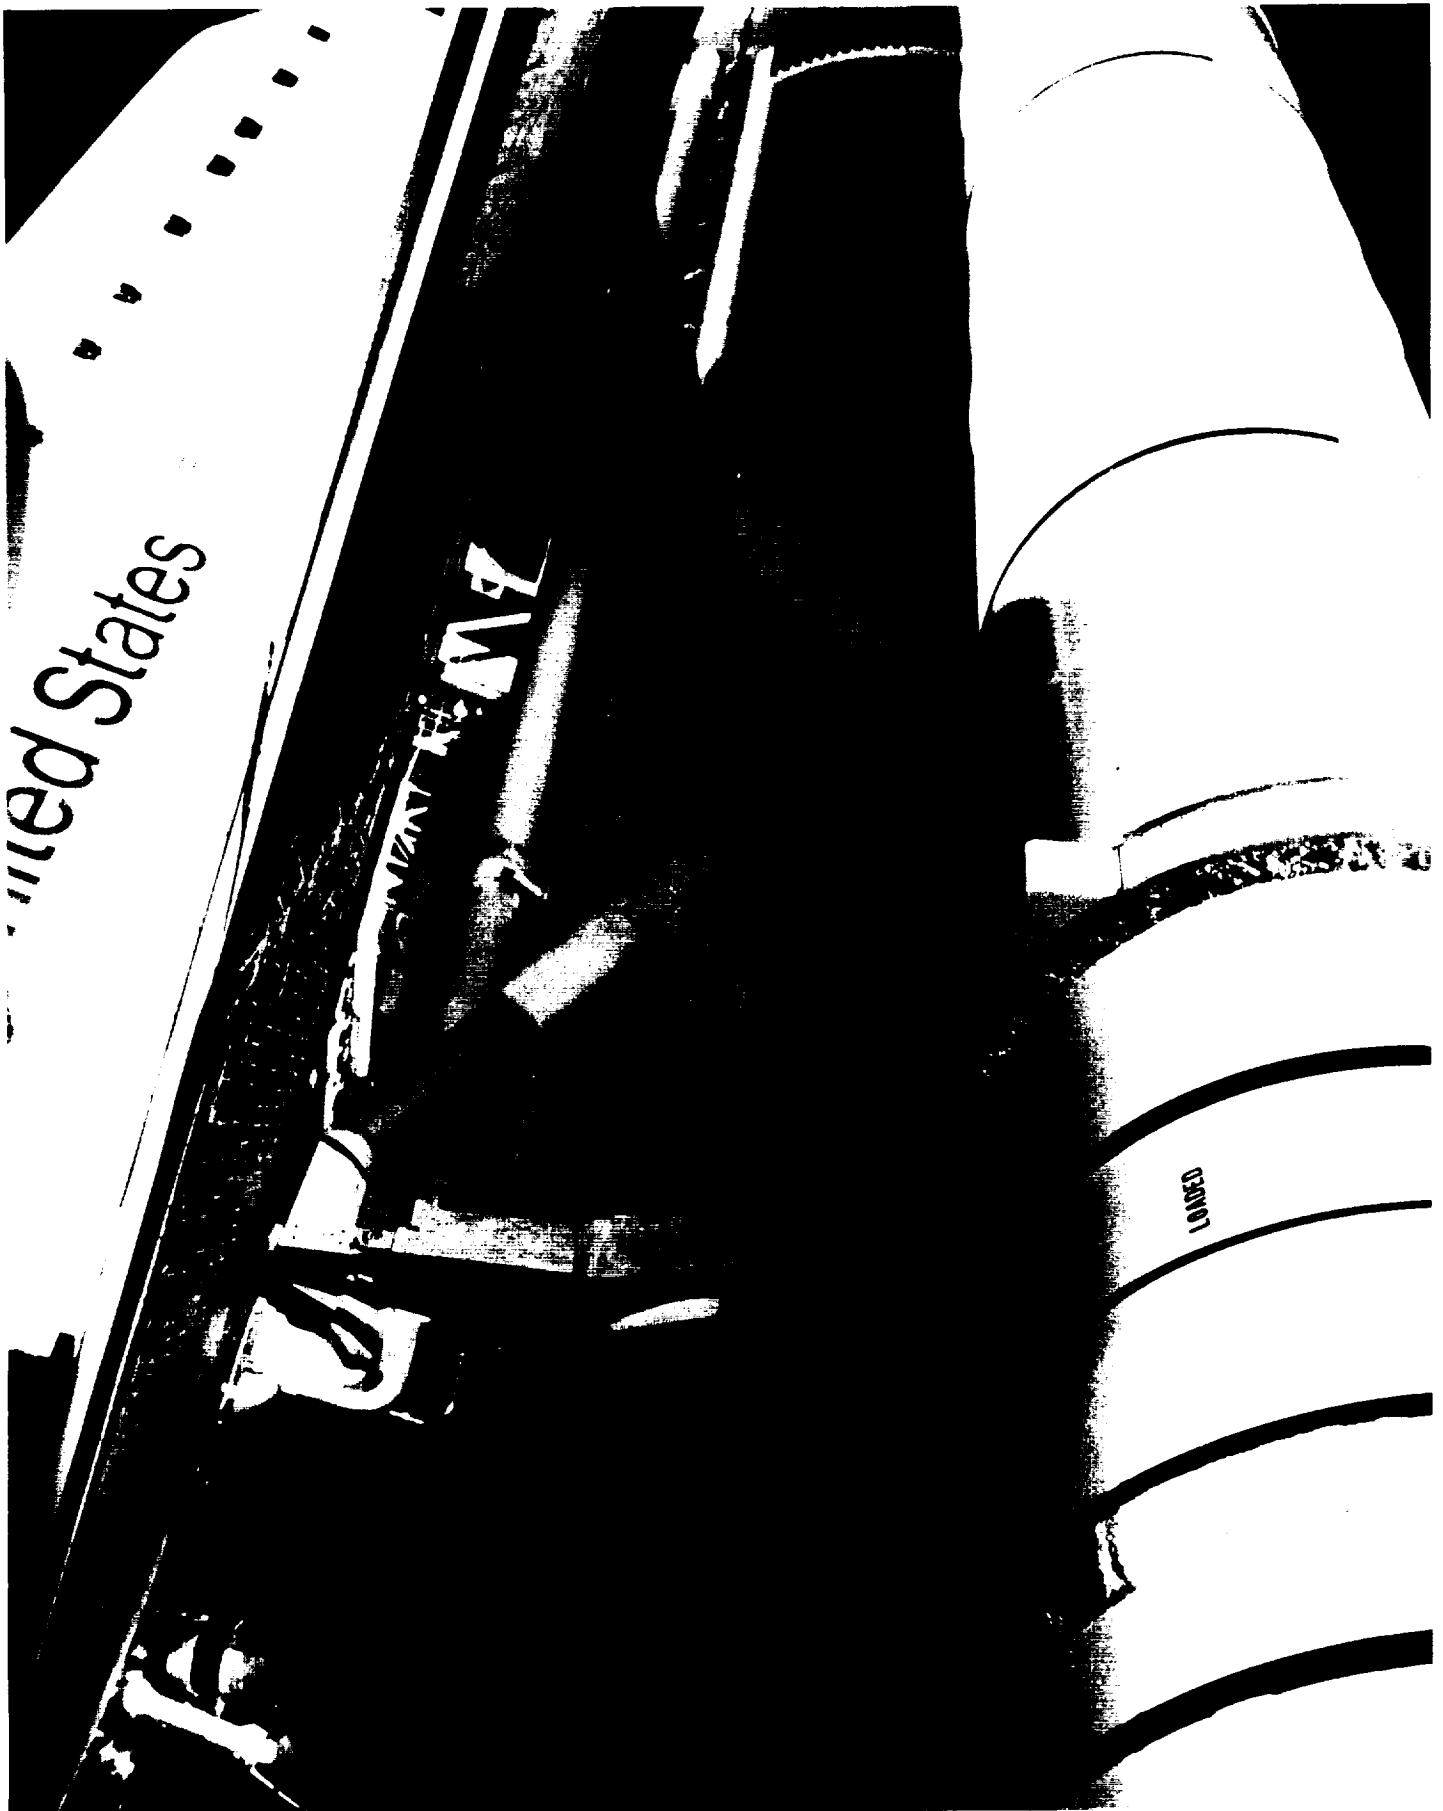
Condensate, but no ice or frost, was present on the LH2 tank acreage. There were no acreage TPS anomalies.

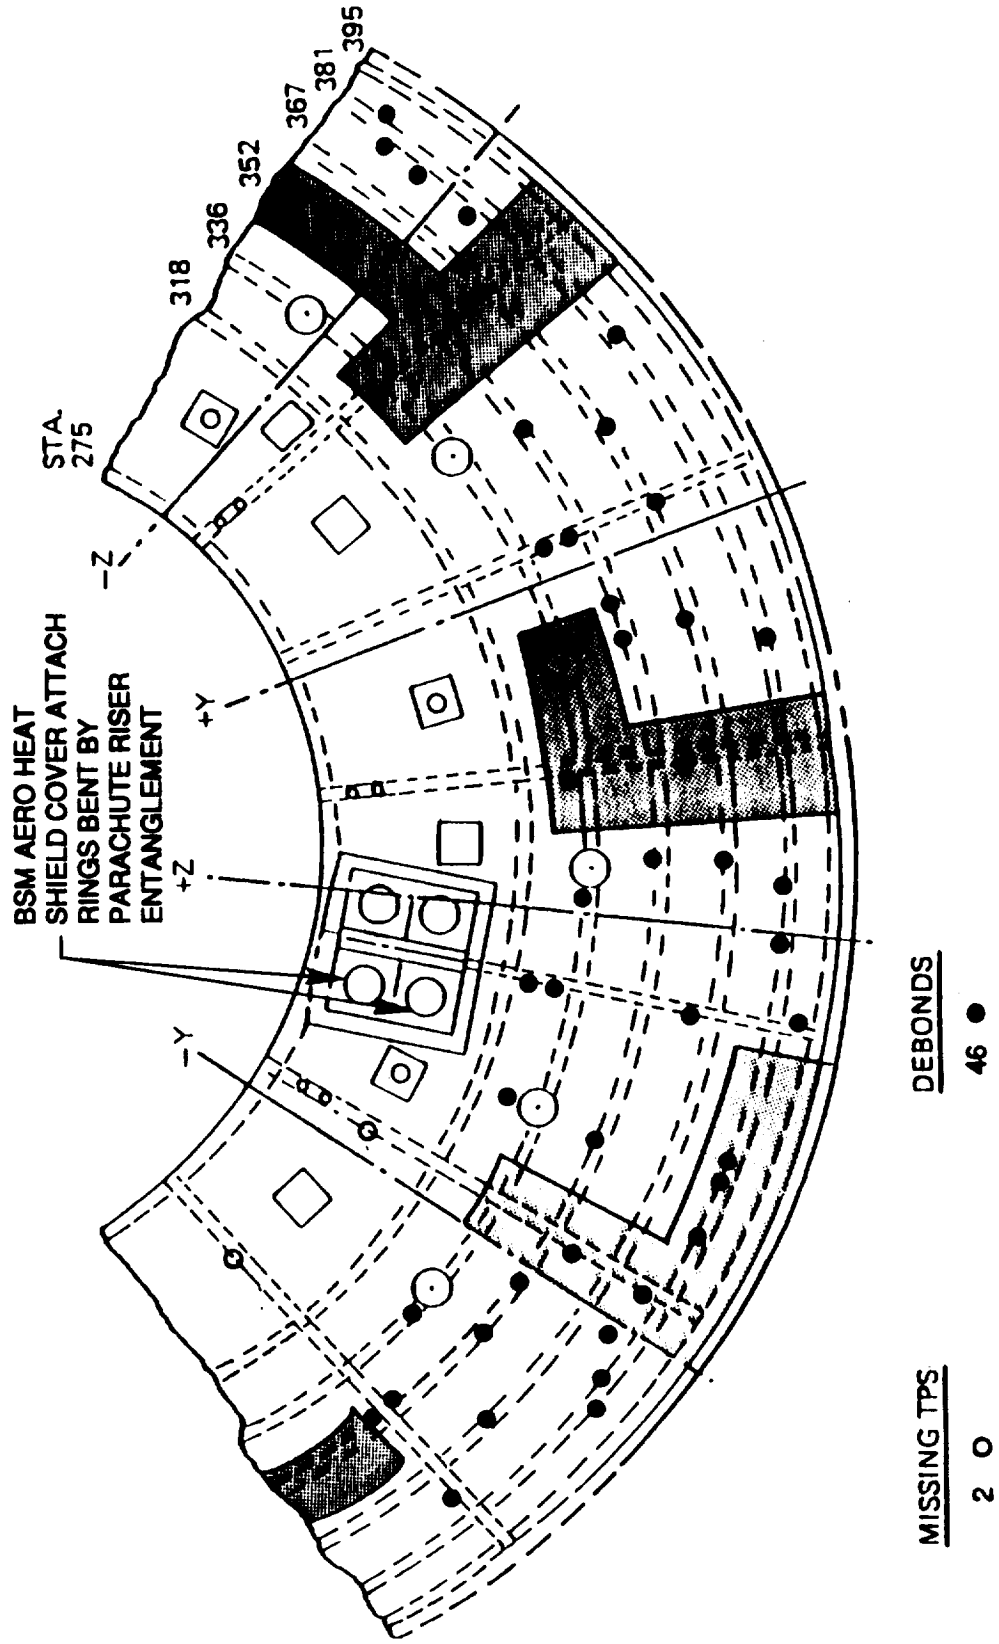
FIGURE 5. RIGHT SRB FRUSTUM

The RH frustum had 46 MSA-2 debonds over fasteners and two areas of missing MSA-2. All BSM aero heatshield covers were locked in the fully opened position, though the two left cover attach rings had been bent by parachute riser entanglement.

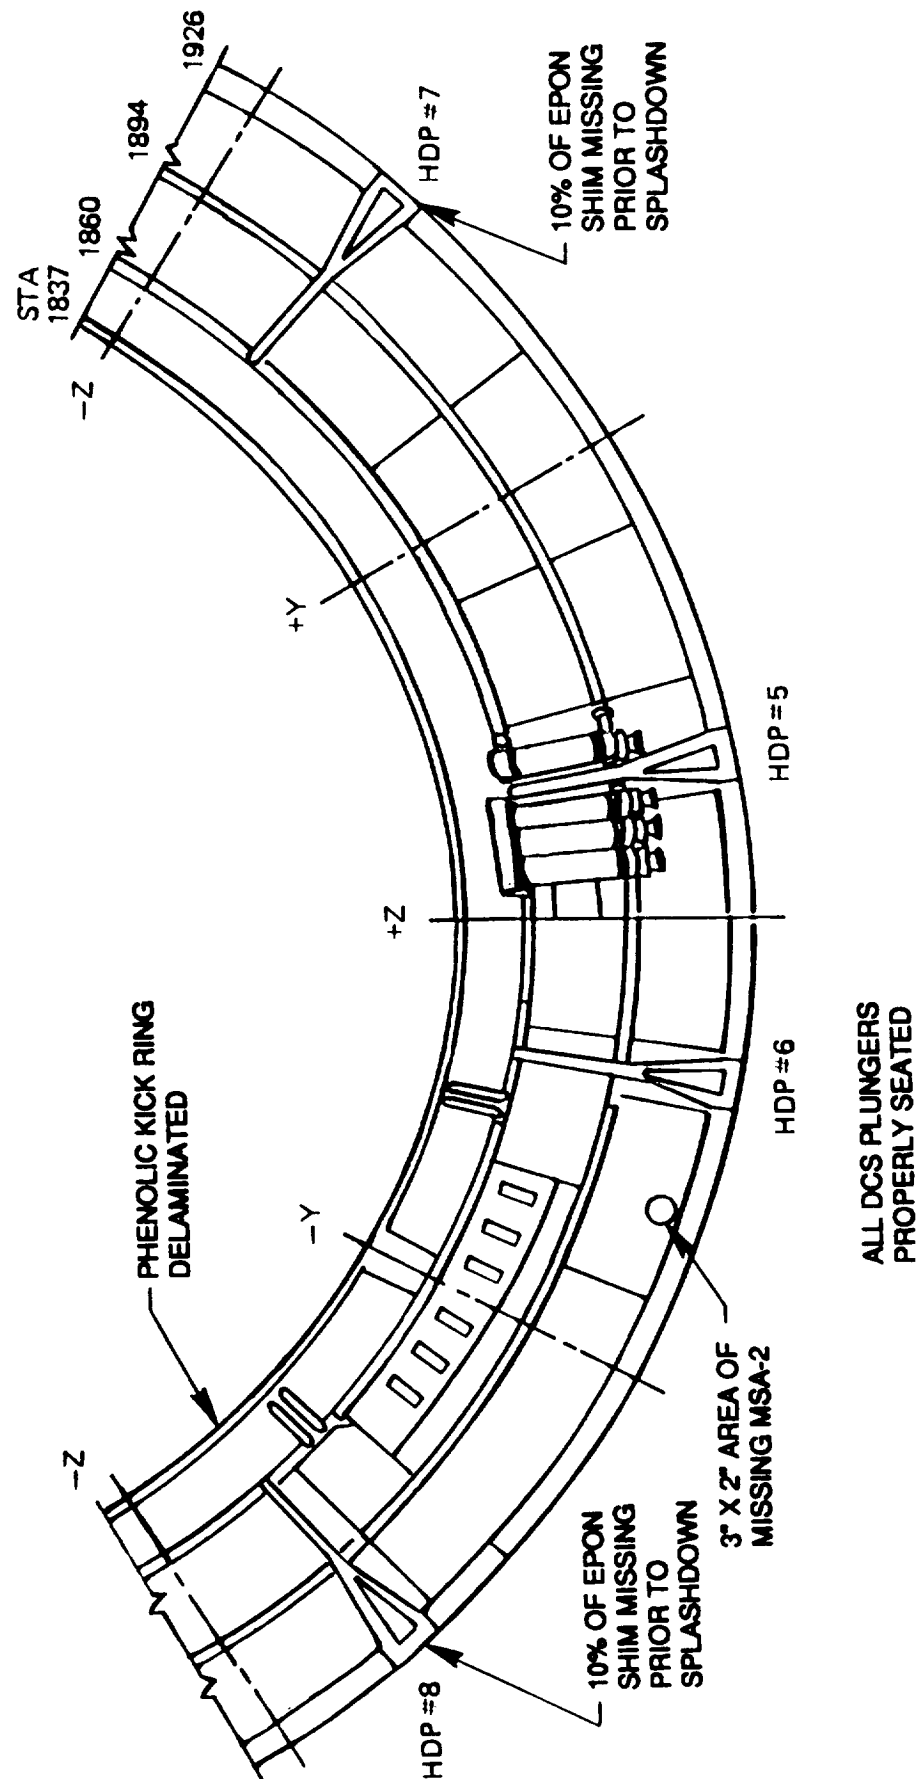
FIGURE 9. **LEFT SRB AFT SKIRT EXTERIOR TPS**

The phenolic material on the kick ring was delaminated. The K5NA closeouts (protective domes) on the kick ring forward and aft fasteners are no longer used. RTV-133 has replaced the K5NA over the forward fasteners. One 3"x2" area of MSA-2 was missing from the aft skirt acreage TPS near the 1926 ring frame between the -Y and +Z axes. The remaining material was slightly sooted (Figure 9).

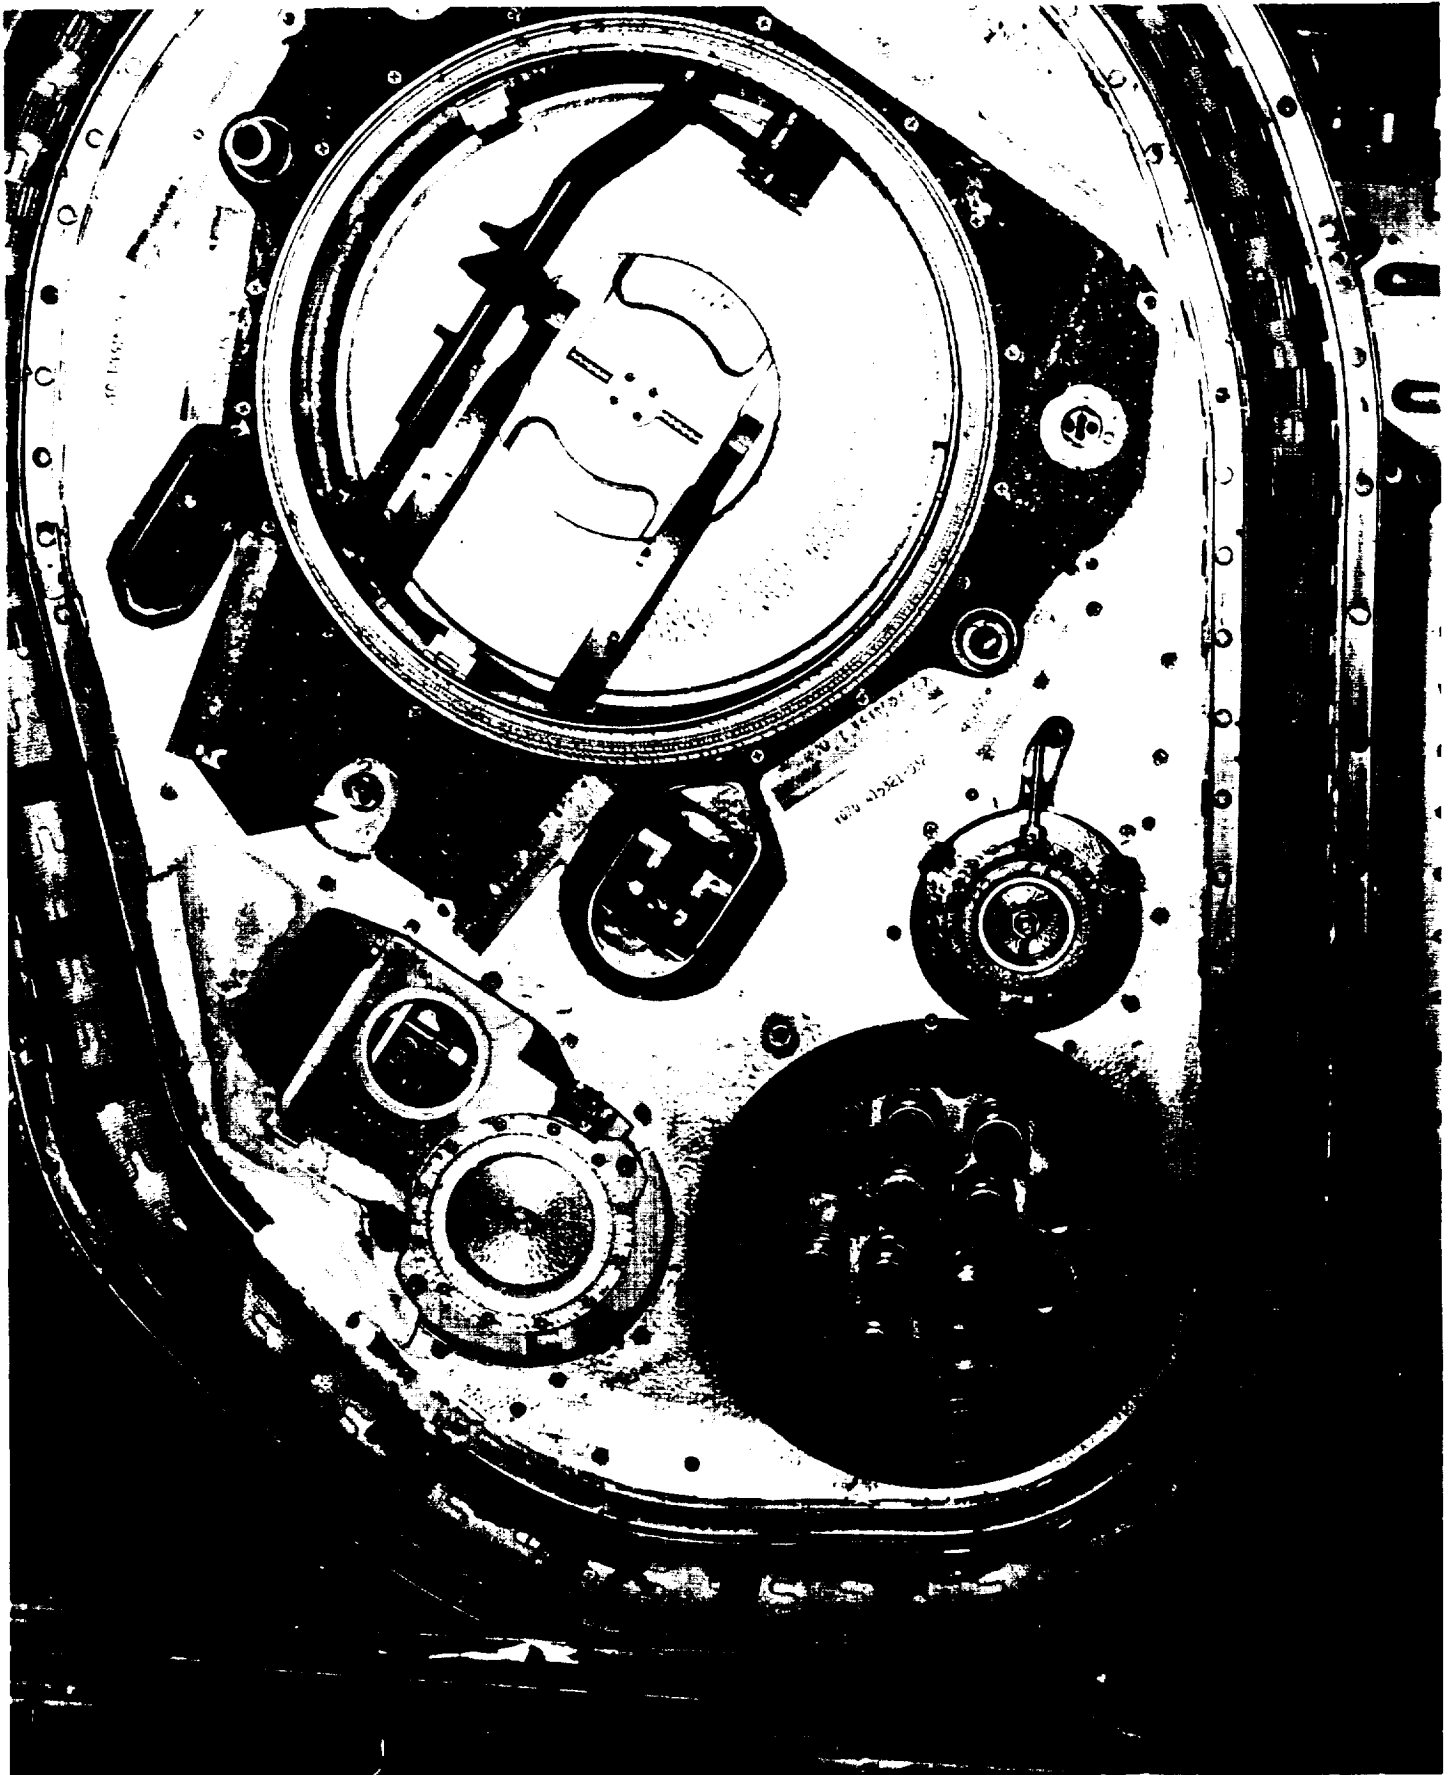
The left ET/ORB attach point (EO-2) hole plugger had not seated and was obstructed by ordnance fragments

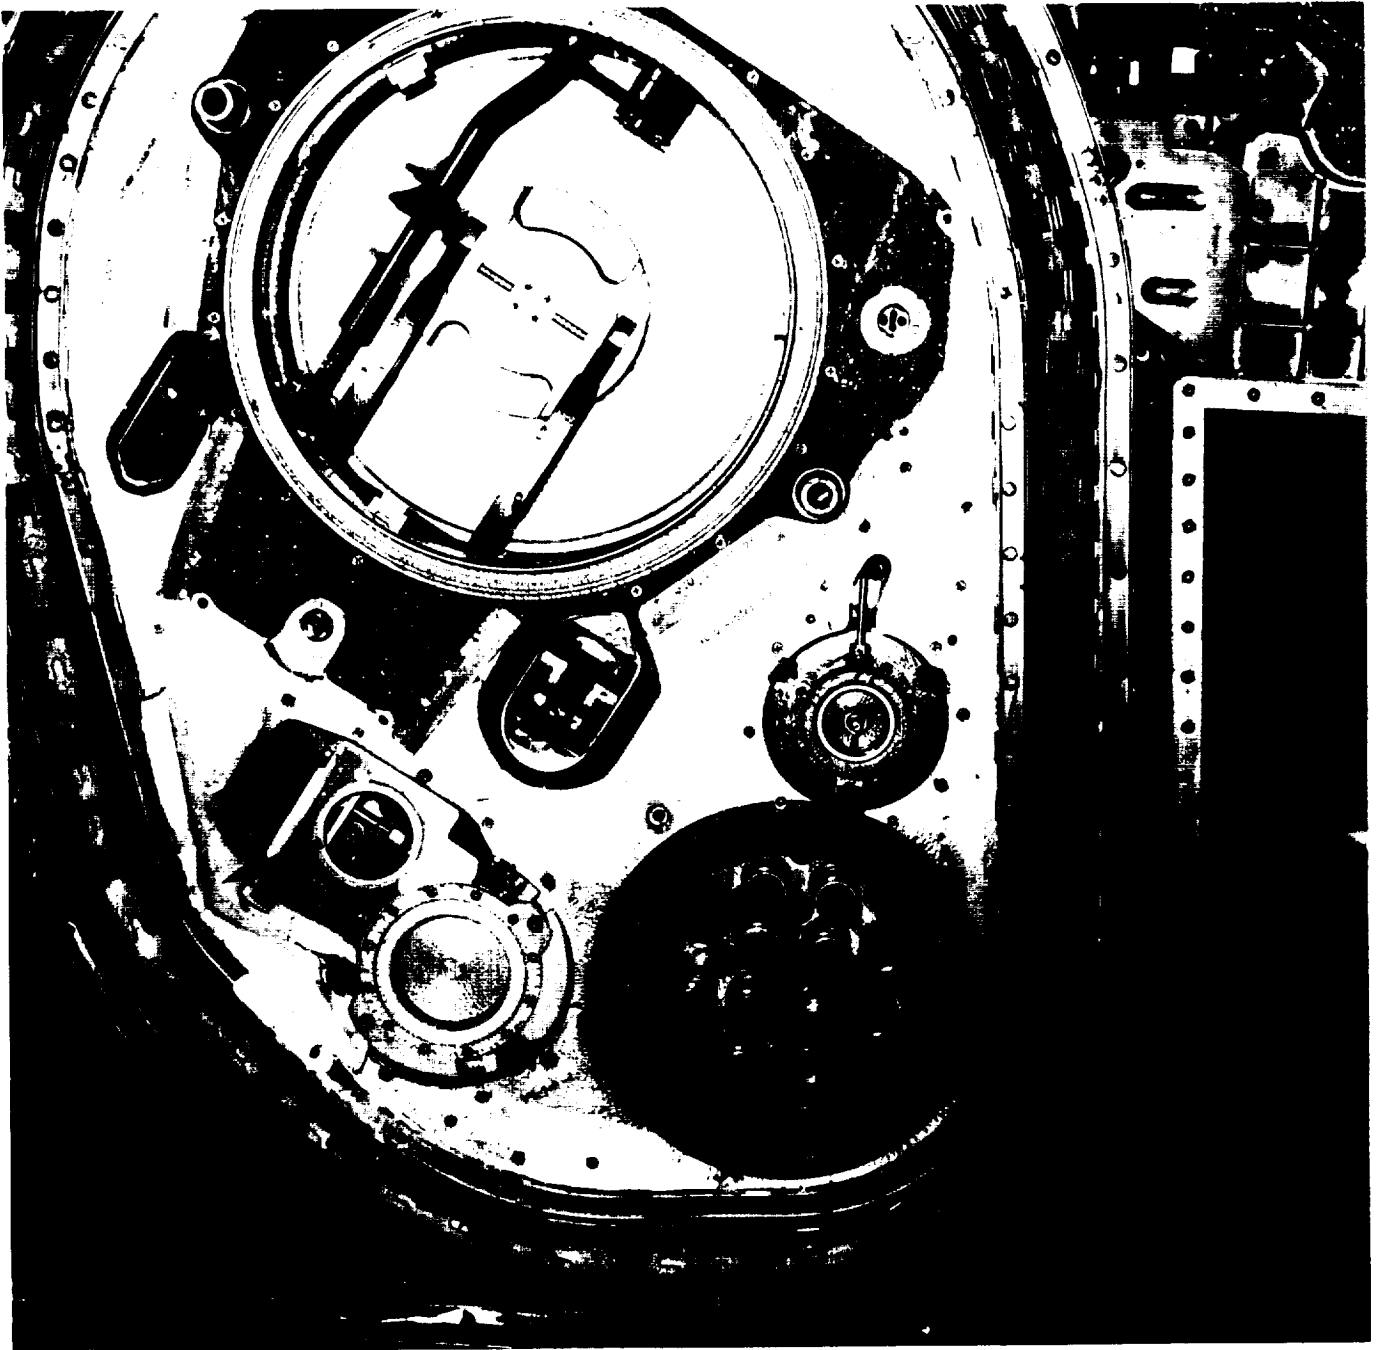
**Figure 2.4.3b****Closeout Picture of the LH2 Umbilical taken by the KSC Debris Team**

A picture of the Orbiter LH2 umbilical (Figure 2.4.3b) taken by the KSC Debris Team after landing indicated that approximately 10 inches of foam material remained near the four inch line connect. The 16 mm umbilical well camera film of the ET LH2 anomalies was shown to the JSC Propulsion and Power Division/EP2 engineers. The JSC engineers suggested that the closeout foam placed near the four inch line connect prior to launch
